NASA CR-120888
Contract NAS3-12023

Final
Report

Composite Overwrapped Metallic Tanks

MARTIN MARIETTA CORPORATION

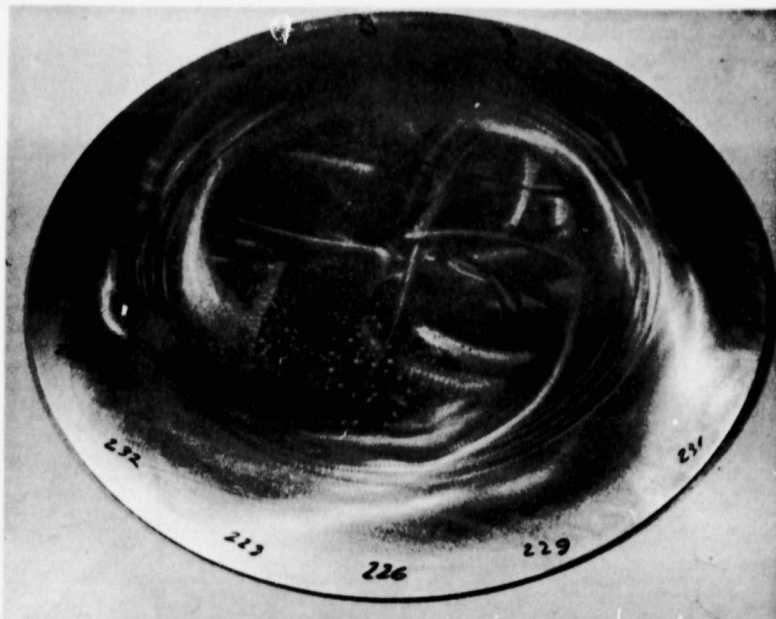
The raw material as received from the supplier contained numerous surface defects and, even though bought to commercial standards, part of the shipment was returned to the supplier for poor workmanship. The variations in flatness from the edge to the center of a sheet, though within specification requirements, made it very difficult to work in the explosive-forming process. Attempts to machine the surfaces to a close tolerance were not successful because of the inability to hold the material flat. In general, it is concluded that the poor quality of the material (see Section B) had a major bearing on the program's lack of success (Fig. 3, 4, and 5).

Figure 3 Explosive-Forming Titanium Blank Showing Rolled-In Defects and Surface Pitting Remaining After Attempts to Grind the Surface under a Coolant

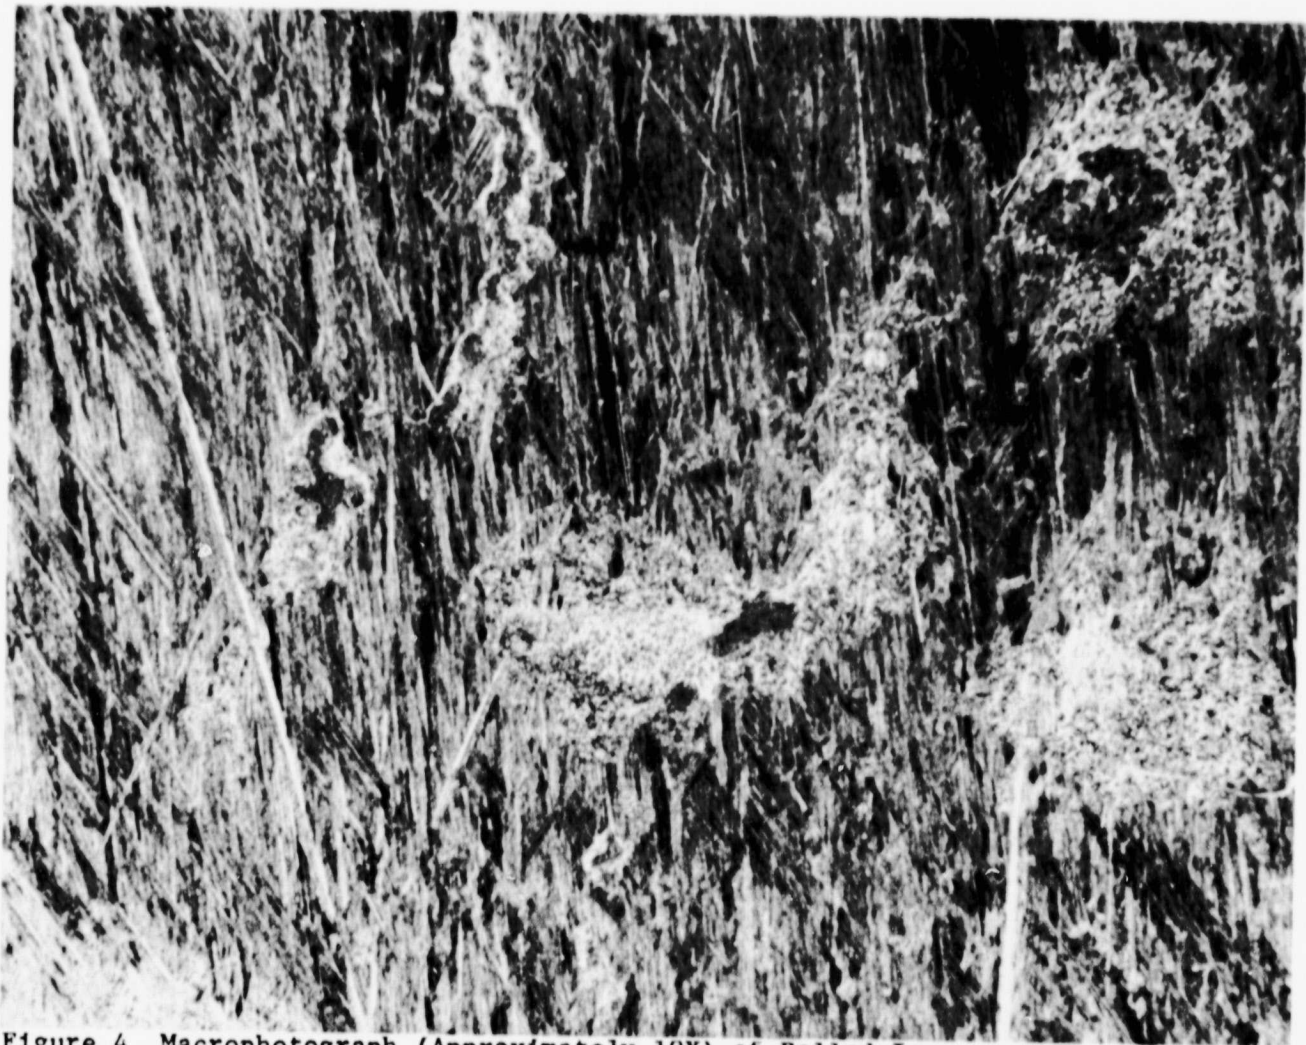
Figure 4 Macrophotograph (Approximately 10X) of Rolled-In Surface Defects in Titanium Plate Shown in Figure 3

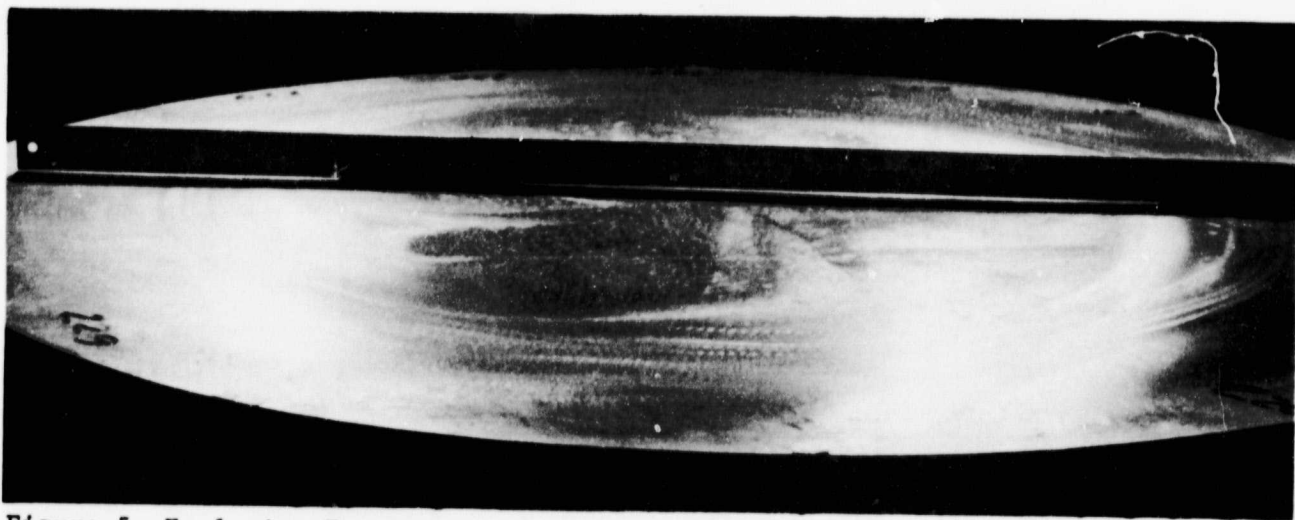
Figure 5 Explosive-Forming Blank (Same as Fig. 3 and 4) Illustrating Deviation From Flatness

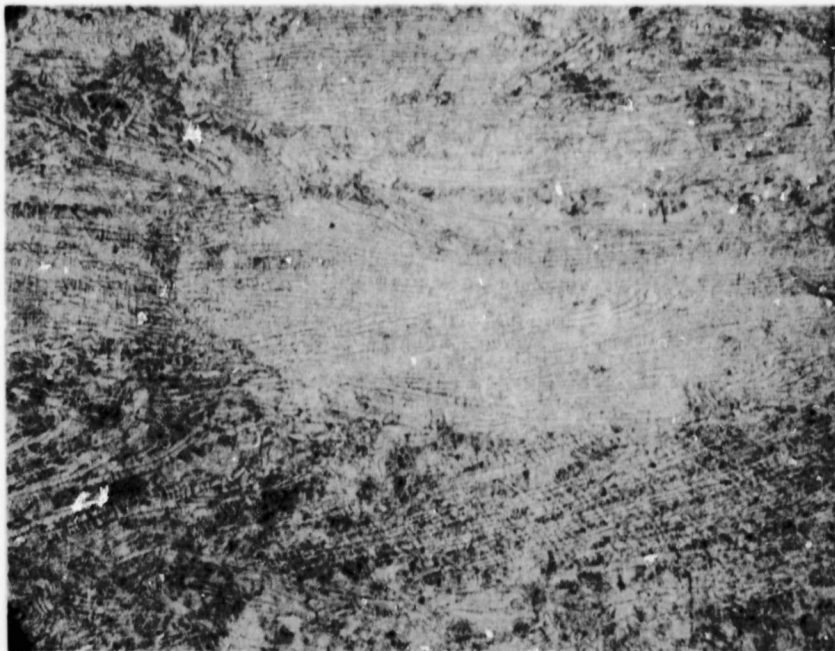
A metallurgical investigation as to the cause of failures was then undertaken. The normal cause for forming failures in titanium (a hard face-oxidized surface and contamination) was suspect. Investigation revealed that improper annealing by the producer rather than contamination was the cause. Mill records were studied and it was determined that one group of the plates had been annealed at 1500°F for 30 minutes and the second group at 1500°F for 15 minutes. While normal tensile tests did not reveal the lack of a proper anneal, the photomicrographs left no doubt as to the material condition. Photomicrographs (Fig. 7 and 8) show the heavily textured grain structure with no indication of alpha surface scale. All the formed domes listed in Tables 1 and 2 exhibited crosshatched microcracks (Fig. 9). The crosshatched microstructure automatically scrapped all domes that had been produced to this point even though they did not indicate conditions of surface cracking. The normal equiaxial grain structure for this alloy is shown in Figure 10.

Figure 7 Photomicrograph of Cross Section at 100X from Failure Area of Dome C-2 Showing Hot Roll Texture

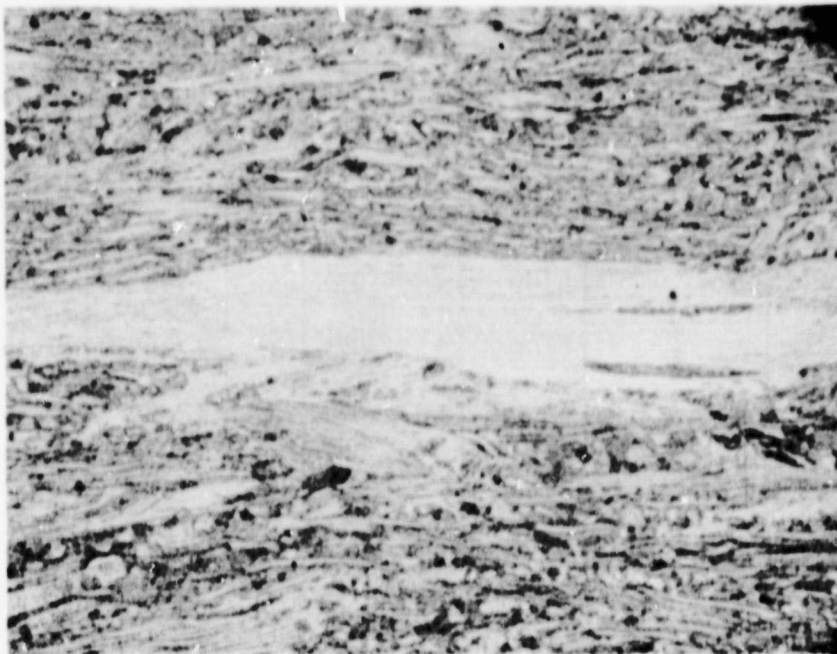
Figure 8 Photomicrograph of Longitudinal Cross Section at 100X of As-Received "C" Plate

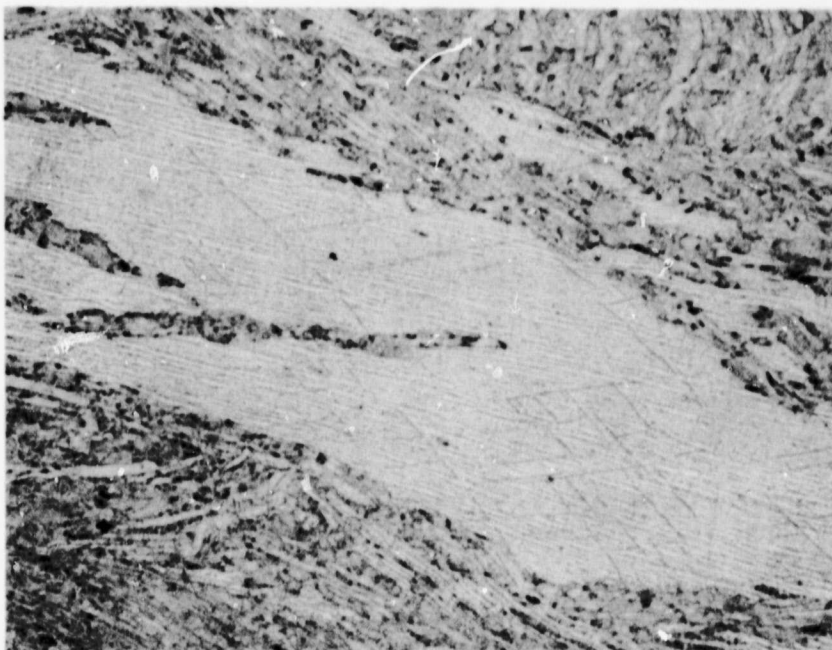
Figure 9 Photomicrograph of Cross Section at 100X from Failure Area of Dome D-3 Showing Crosshatch Cracking

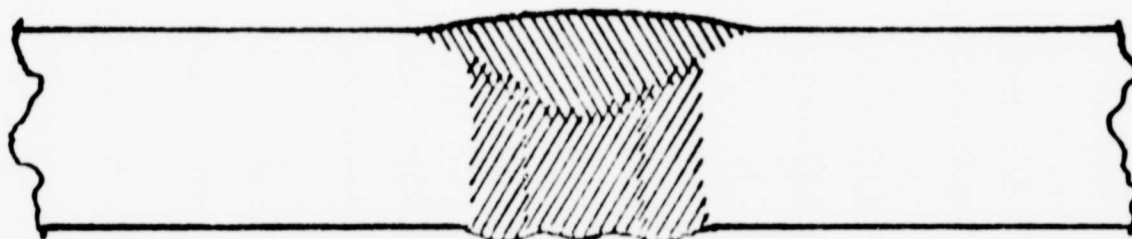
Figure 35 Defective Single-Pass Electron Beam Weld and Proper Triple-Pass Weld

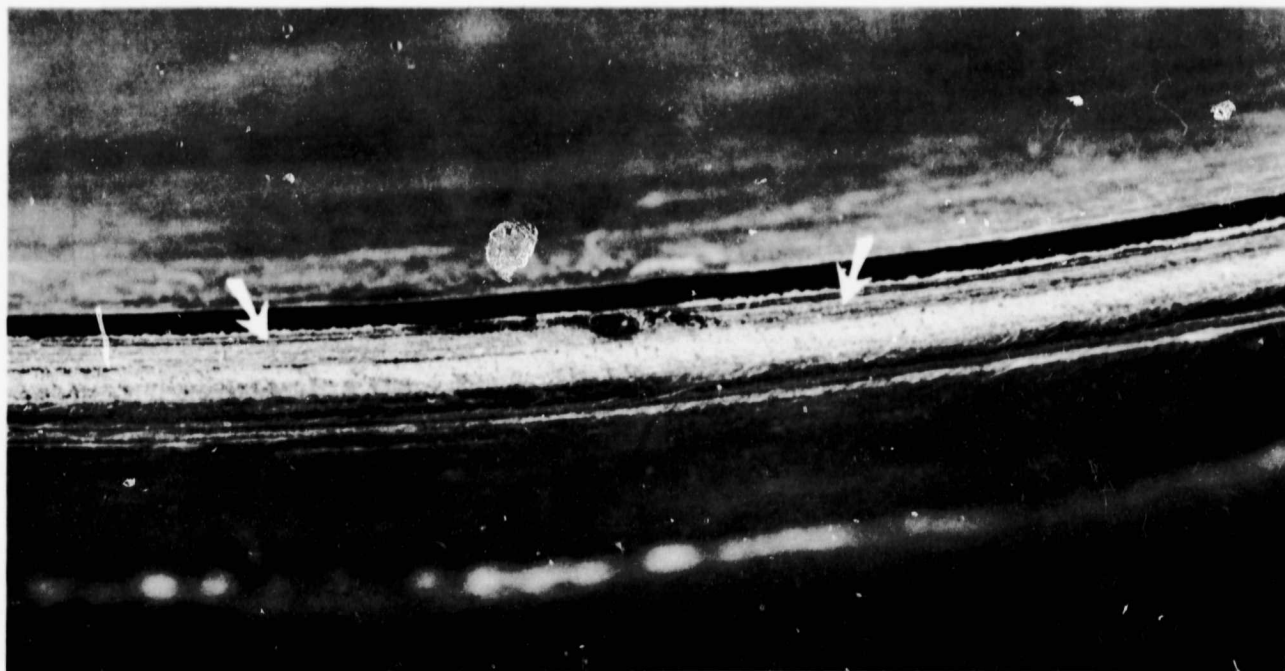
S/N 1 failure analysis indicated that the failure was due to the electron beam partially missing the joint. The defect was camouflaged by the combination of the cosmetic pass and the near diffusion bond created by the close fit and elevated temperature. The welding sequence used on the first two tanks made a double-wall radiograph mandatory. Difficulty in interpreting the double wall X-ray added to the problem of acceptance testing. Ultimately S/N 1 was cut apart at the girth joints, remachined, and joined with a new cylindrical section. Since S/N 1 sustained heavy scratches on the tank liner surface when the overwrap was removed, it became a prototype for liner reworking but was not overwrapped or tested.

S/N 2 failed in the same manner, even though prior to testing it had been reworked as S/N 1 had been. Figure 57 shows the joint indicating a lack of fusion. As indicated in other portions of this report, the holding fixtures were reworked and the entire radiographic process revised. In the process of attempting to rework the girth welds of the remaining tanks, the serial numbers of the tanks no longer reflected the chronological order of fabrication or test.

Figure 57 Origin of Failure at Girth Joint; Machining Marks Indicate Lack of Fusion (Typical of S/N 1 and S/N 2)

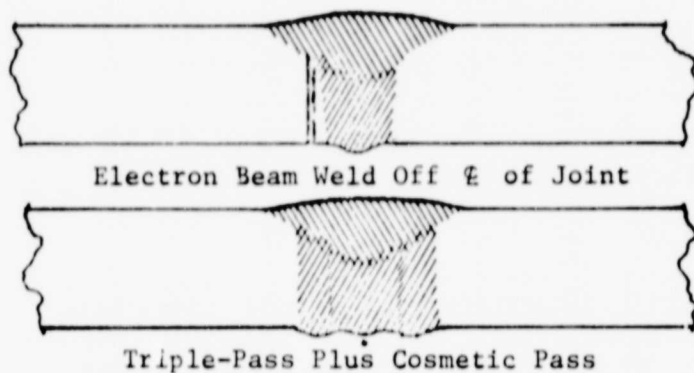
Figure 58 Defective Single Pass Electron Beam Weld and Proper Triple-Pass Weld

After the welding equipment had been reworked and the three-pass weld developed for the girth weld (Fig. 58), S/N 3 was the only tank to fail in the girth weld. Its failure mode, shown in Figure 59, indicates a crack in the area contaminated by mild steel that was melted and splattered from the weld holding fixture while performing the weld.

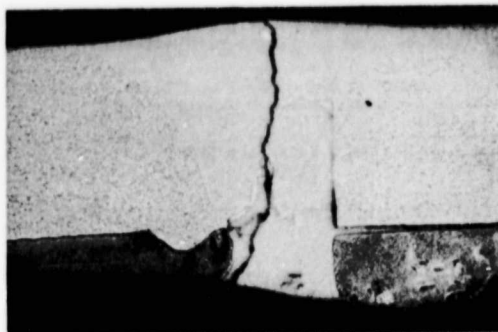
Figure 59 S/N 3 Failure in Girth Joint due to Weld Contamination

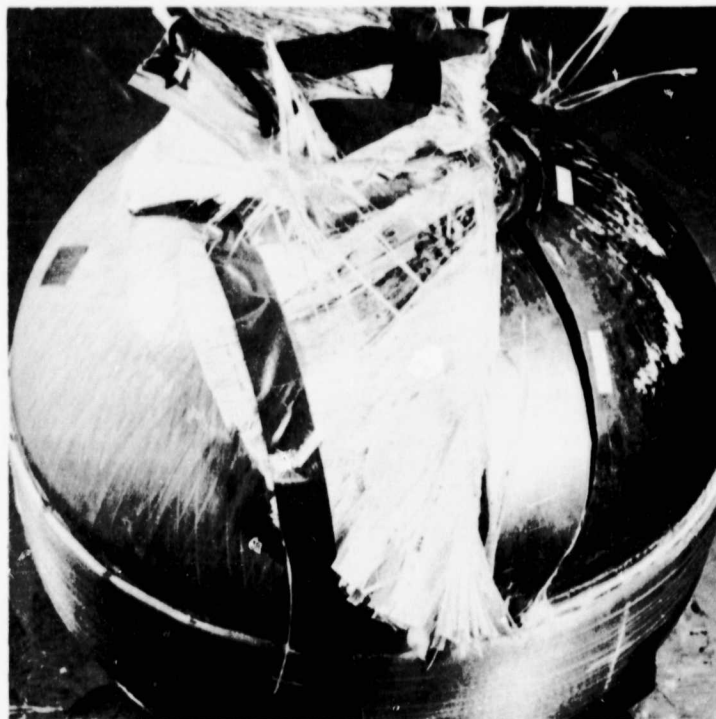
S/N 4 burst at 3854 psi during the hydrostatic sizing operation. This was the first tank that failed outside the girth weld. In this case, the failure was initiated at the dome-to-fitting joint (Fig. 60). The cause of failure appeared to be a combination of a lack of ductility (Fig. 61 and 62) and joint mismatch. The mismatch was not a typical joint misalignment, but appeared to be a condition referred to as "sink-in" brought about as the dome-to-fitting joint shrunk under pressure while cooling after the weldment had been completed. A fix for correcting the "sink-in" effect utilizing hot forming is shown in Figure 63. Refer to Table 12 for the forming process.

Figure 60 Photograph of S/N 4 Tank Showing Fracture After Removal of Fiberglass

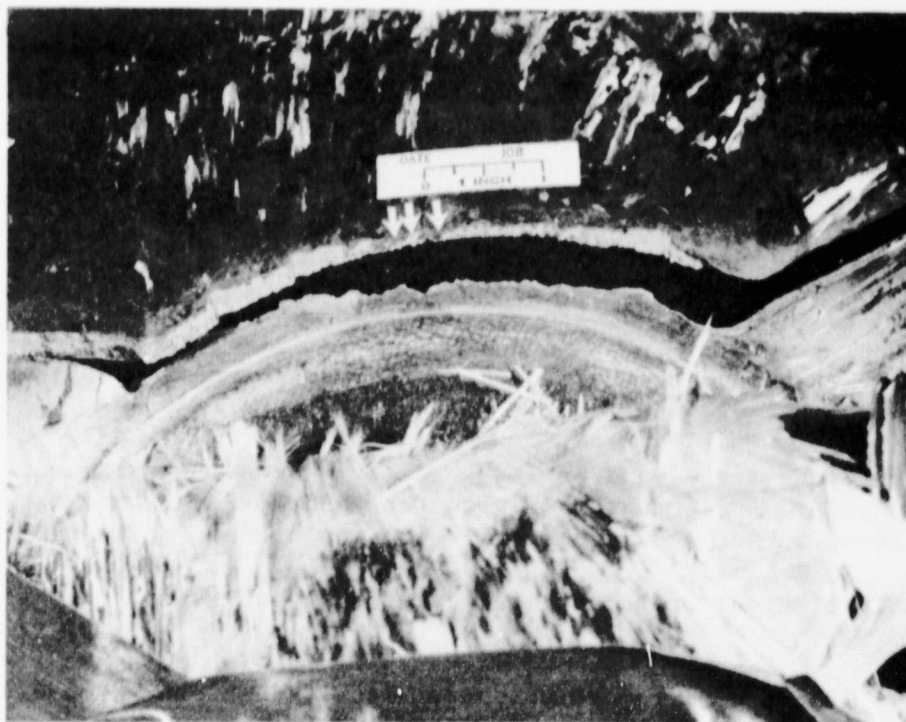
Figure 61 Photograph of S/N 4 Showing Weld Fracture
With Arrows Indicating Approximate
Origin of Failure

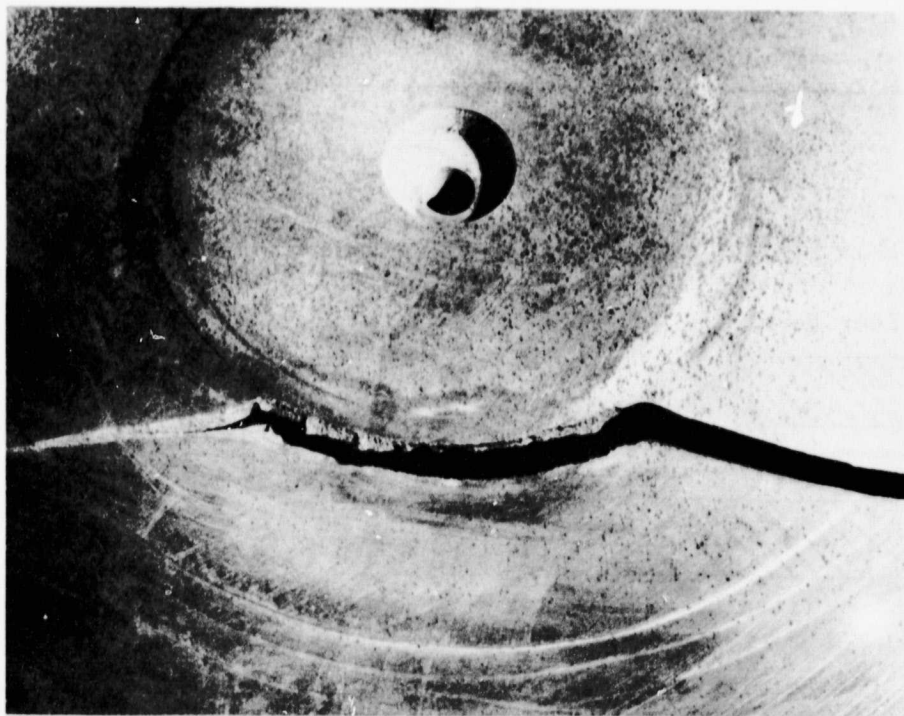
Figure 62 Photograph of S/N 4 Fracture from
Inside the Tank

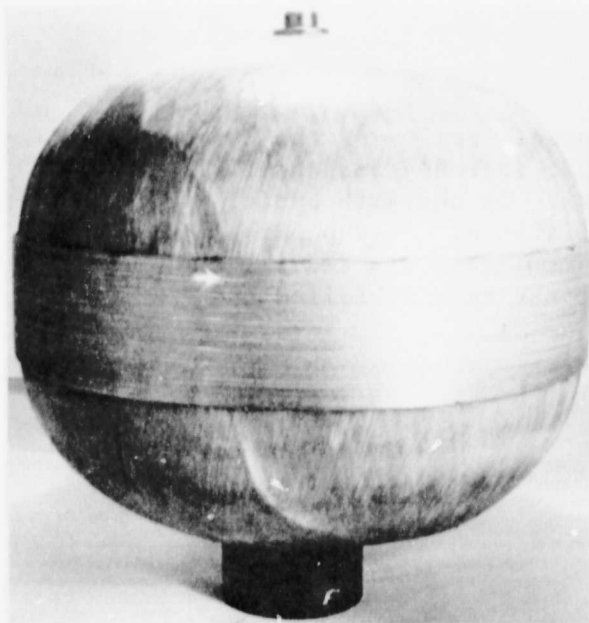
S/N 5 failed at 3660 psi during the hydrostatic sizing operation (Fig. 64). This is the only tank that failed in the longitudinal joint of the cylindrical band (Fig. 65). The failure area appeared to have been contaminated by an iron inclusion when a portion of the carry-through bolt that was a part of the weld tooling partially melted during welding. This was not detected by X-ray (Fig. 66).

Figure 64 Photograph of S/N 5
Showing the As-Failed
Configuration; Arrow
Indicates Approximate
Origin of Fracture

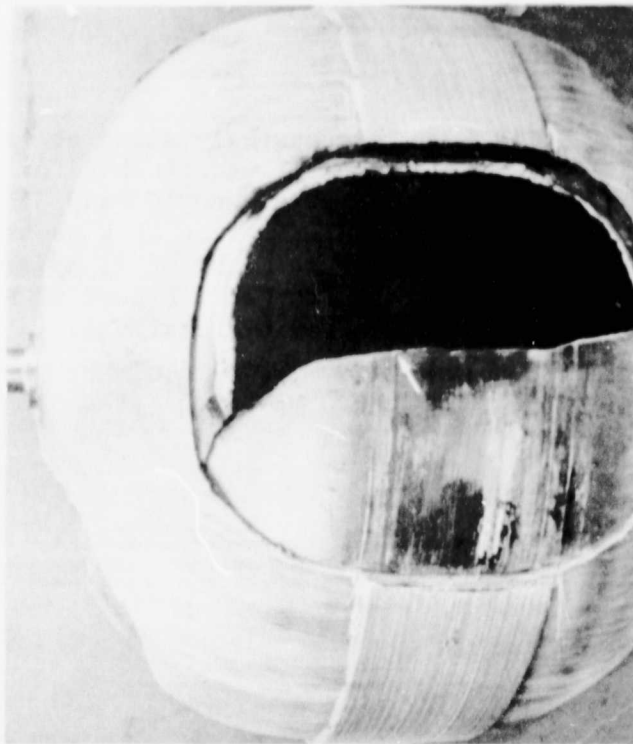
Figure 65 Photograph of S/N 5 Showing
Exposed Fracture Surface;
Arrow Indicates Failure
Origin

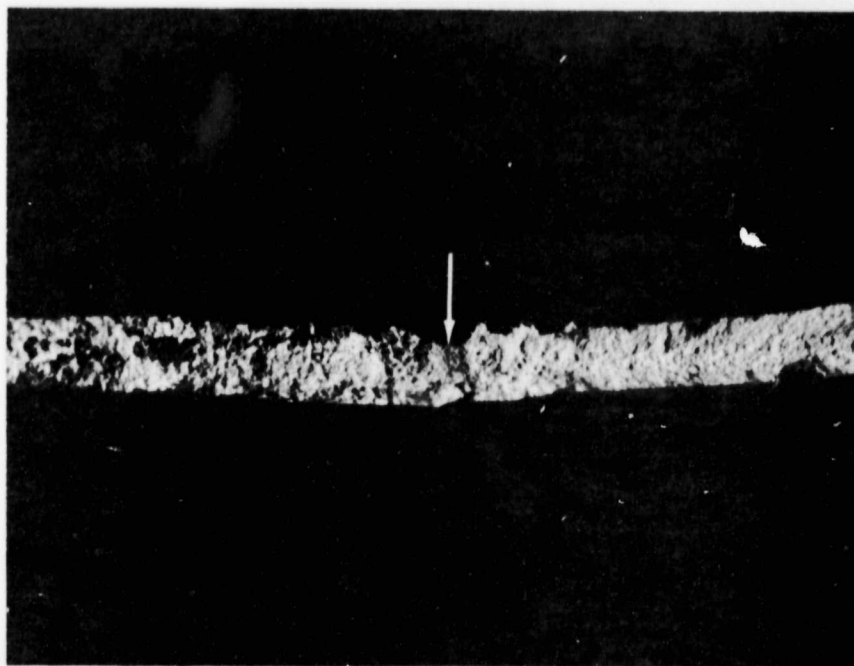
Figure 66 Photomicrograph of Fracture Surface on
S/N 5; Arrow Shows Origin of Failure

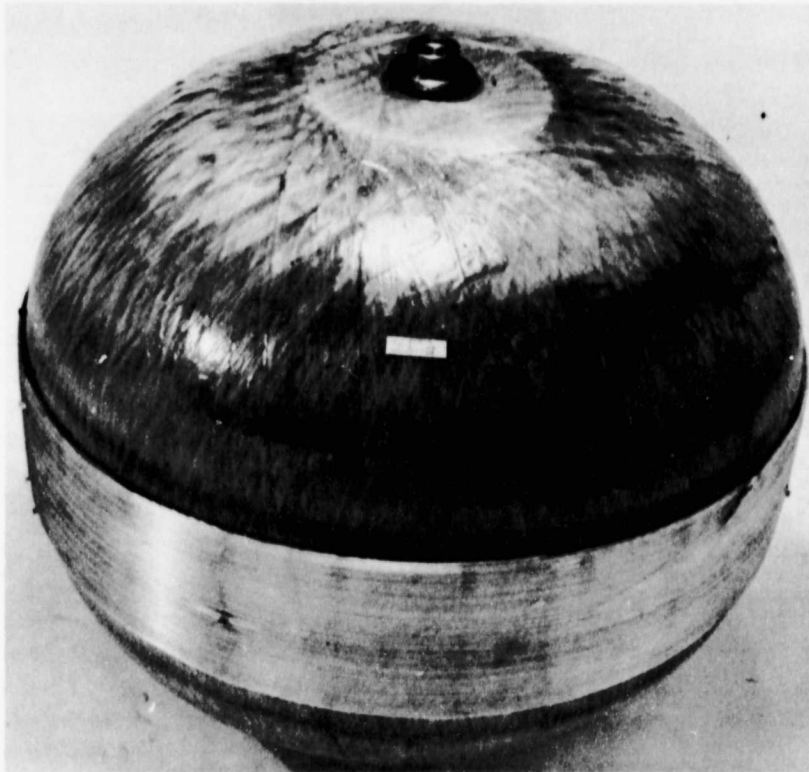
S/N 6 was successfully sized at 4527 psig. Following the hydrostatic sizing, it was checked for volume increase and then cycled at 75°F between 100 and 3360 psi. On the 49th cycle, there was an indication of a probable failure. On the 50th cycle a pressure decay of 21 psig/sec confirmed the failure and the test was stopped. Figure 67 shows the tank as failed and prior to the failure analysis.

Figure 67 Photograph of S/N 6 Showing As-Failed Configuration

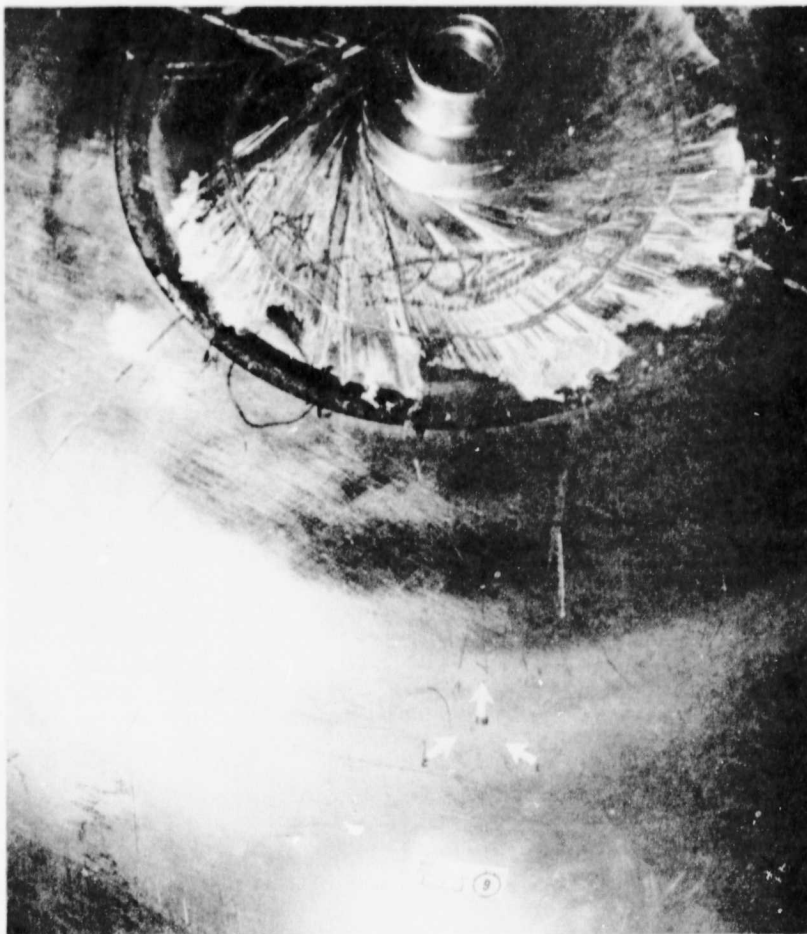
Figure 68 Photograph of S/N 6 Showing Leak Area

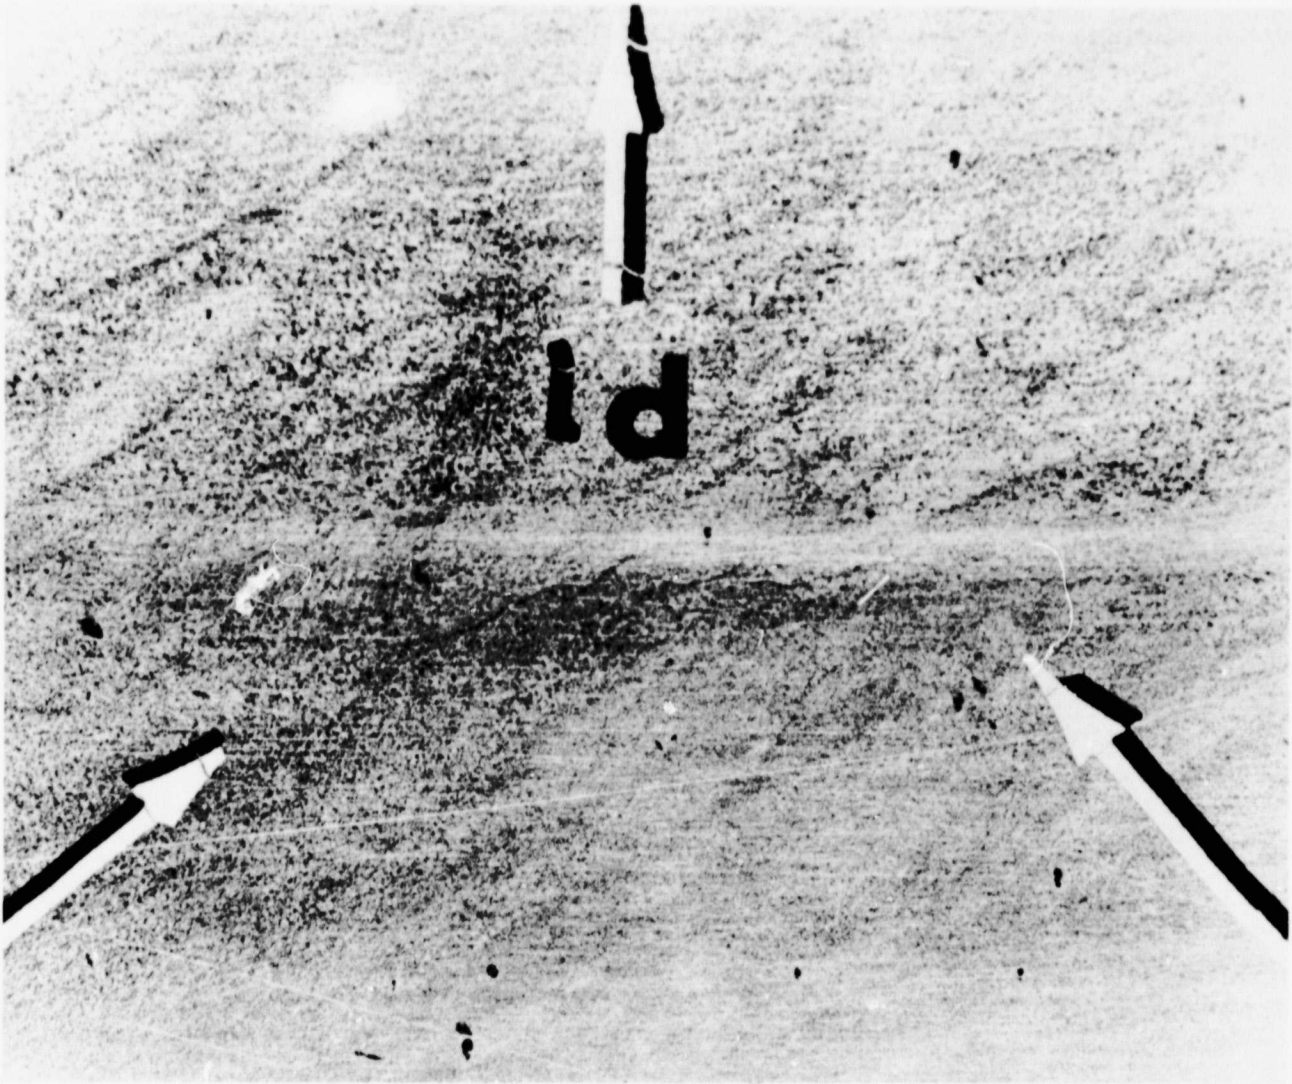
Figure 69 Photomicrograph Showing Fracture of S/N 6 Located on the Exterior of the Dome at Station 59

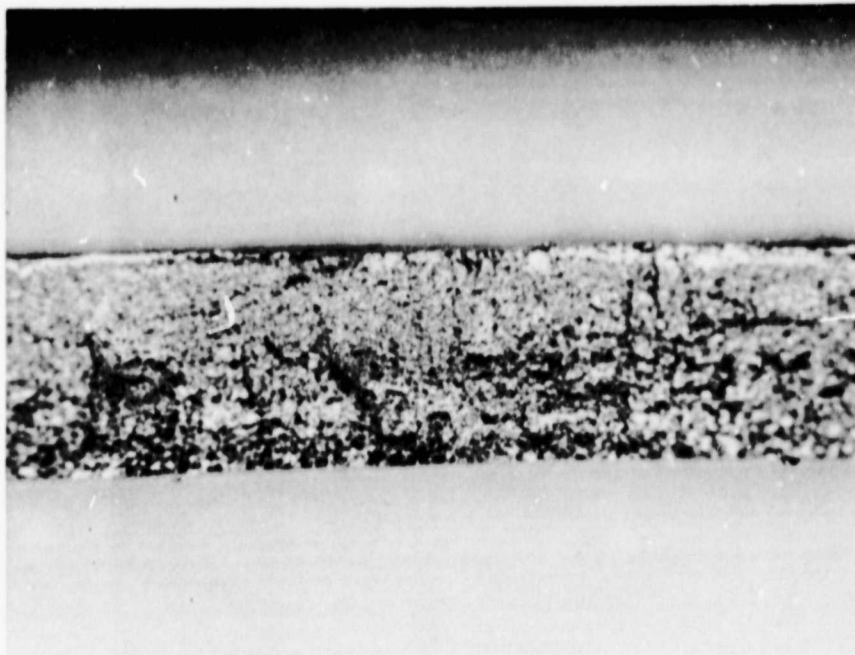
Figure 70 Cross Section of Failure Area on S/N 6
Looking at End of Crack Shown on Figure 67

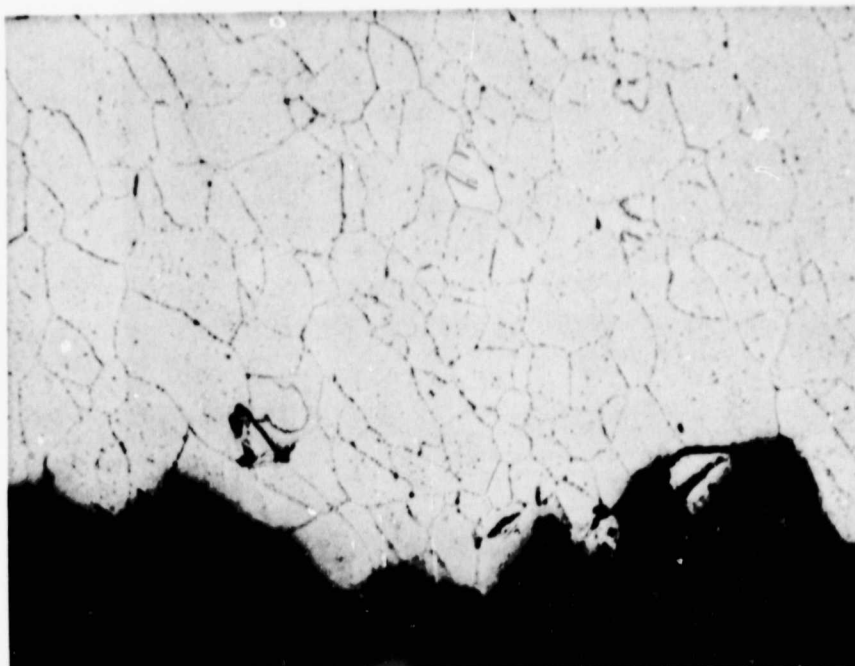
Figure 71 Section of S/N 6 Failure Looking at Edge
of Fracture That Follows Grain Boundaries
(Magnification, 250X)

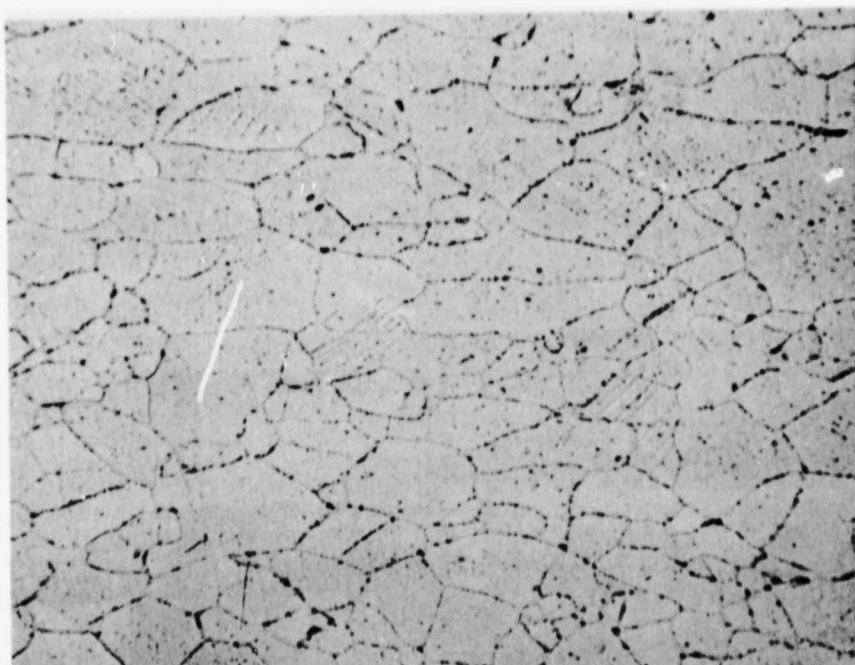
Figure 73 Photomicrograph of the Micro-
structure Through the Leak Area
of S/N 6 (Note the "Dirty"
Microstructure and Grain Boundary
Precipitant, 250X)

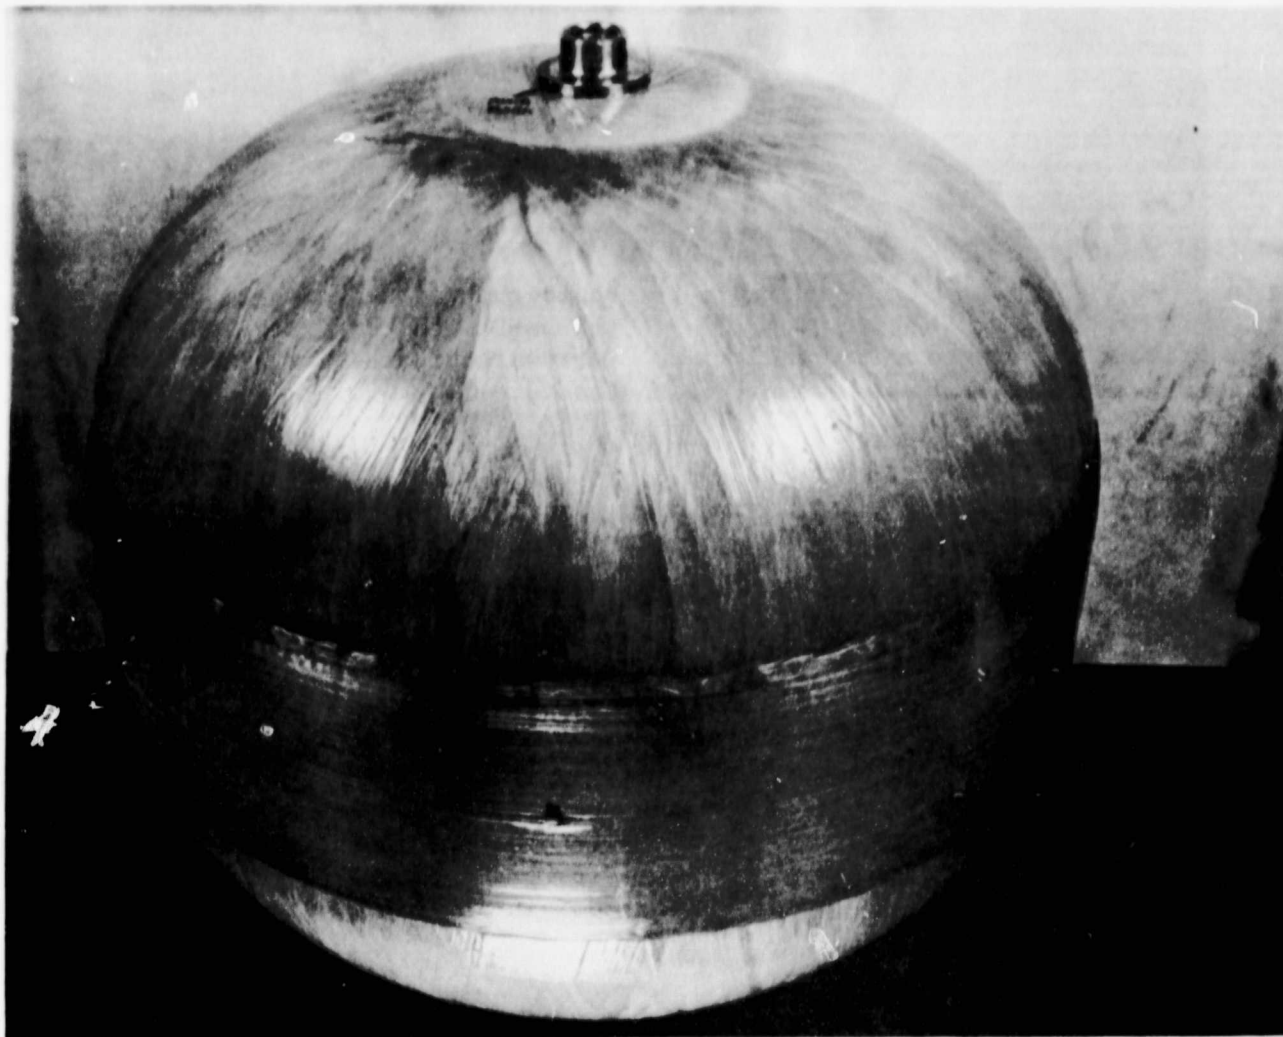
S/N 7 was hydrostatically sized at 4469 psig. The volume after sizing was determined to be 7327 in.³ The vessel was then hydrostatically pressurized at 75°F to burst. The tank failed at 5062 psig (Fig. 74). The failure initiation point was in the girth weld. Analysis indicated the failure was due to simple overpressure with no metallurgical cause for failure.

Figure 74 S/N 7 after Failing at 5062 psi (Note the Lack of Fragmentation or Shattering of Overwrap Material)

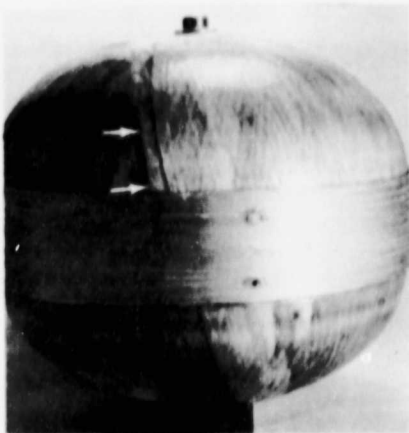
S/N 8 failed prematurely during hydrostatic sizing at 3432 psig (Fig. 75). The initiation point appeared to be at the dome-to-end fitting joint as indicated in Figure 76 and was due to lack of fusion (Fig. 77).

Figure 75 Photograph of Tank S/N 8 Showing the As-Failed Configuration (Arrows Indicate Subsurface Fracture)

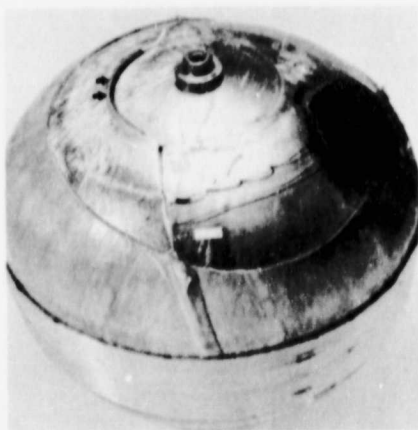
Figure 76 Photograph of Tank S/N 8 Showing Exposed Fracture Surface (Arrows Indicate Approximate Origin of Failure)

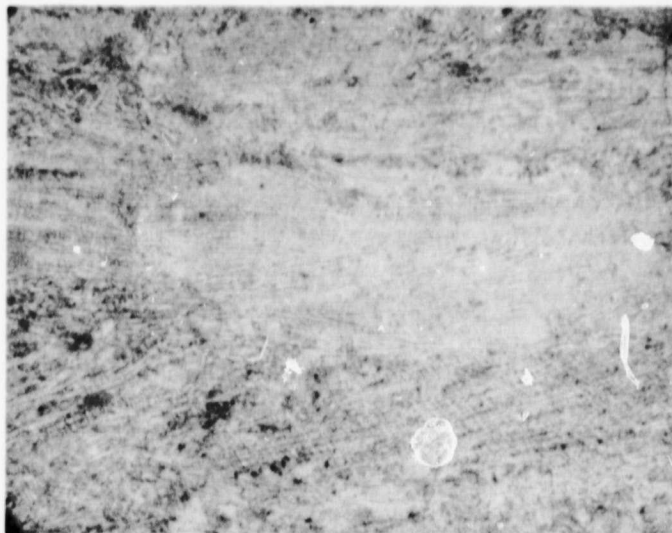
Microexamination of cross sections taken from the failed areas of the two domes C-2 and D-3 revealed no evidence of alpha scale. The microstructure was predominantly hot-rolled-textured (Fig. 1). Several areas of crosshatch cracking were observed in the microstructure near the failed areas (Fig. 2).

Figure 1 Photomicrograph of Cross Section at 100X from Failure Area of Dome C-2 Showing Hot-Roll Texture

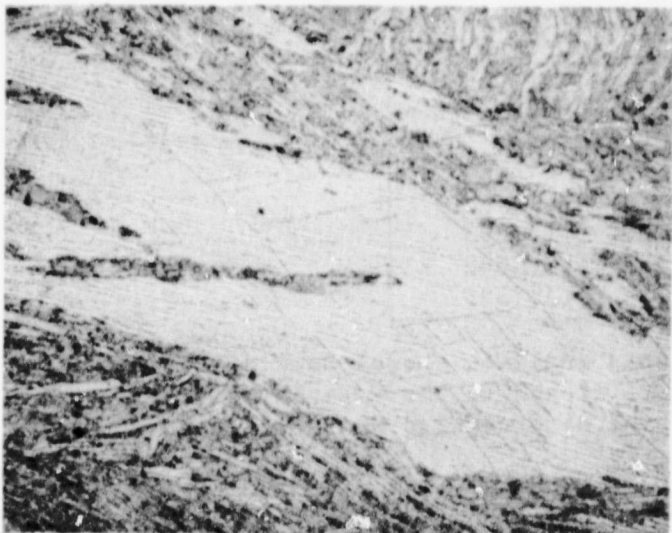
Figure 2 Photomicrograph of Cross Section at 100X from Failure Area of Dome D-3 Showing Crosshatch Cracking

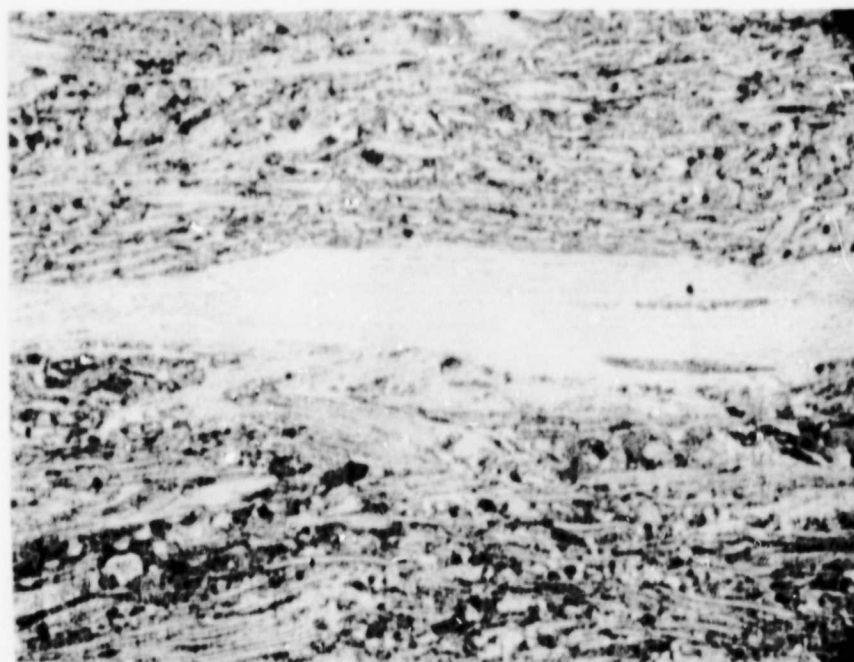
Microexamination of a cross section taken from the as-received plate used for the failed domes revealed no evidence of alpha scale. The microstructure was similar to that in the dome failed areas without the areas of crosshatch cracking (Fig. 3). The structure did not appear to be annealed.

Figure 3 Photomicrograph of Longitudinal Cross Section at 100X of As-Received "C" Plate

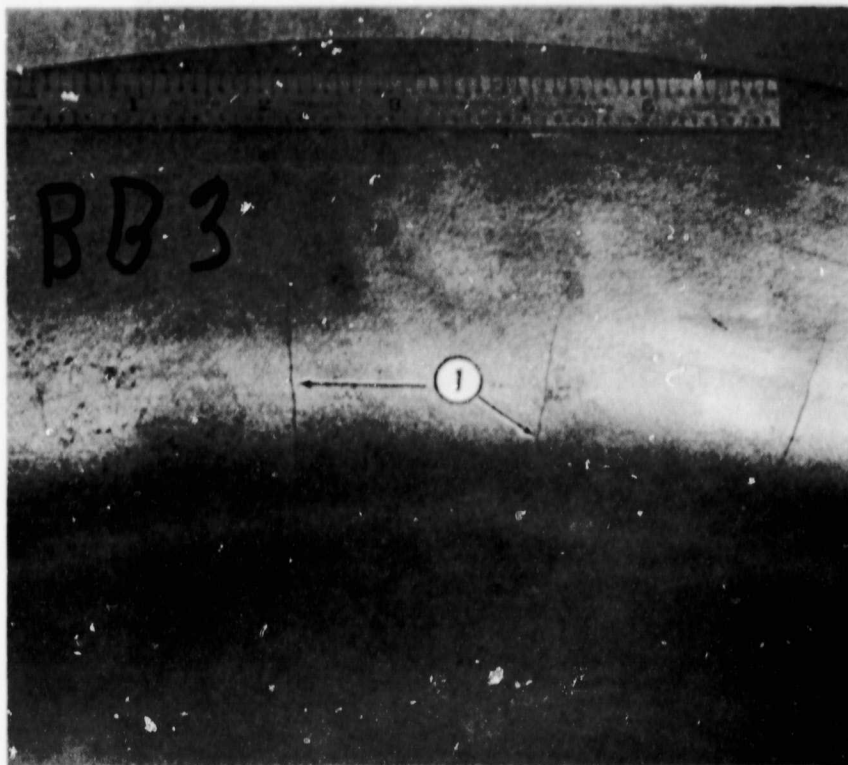
Figure 1 Cracks in the Flange Radius of Dome BB3

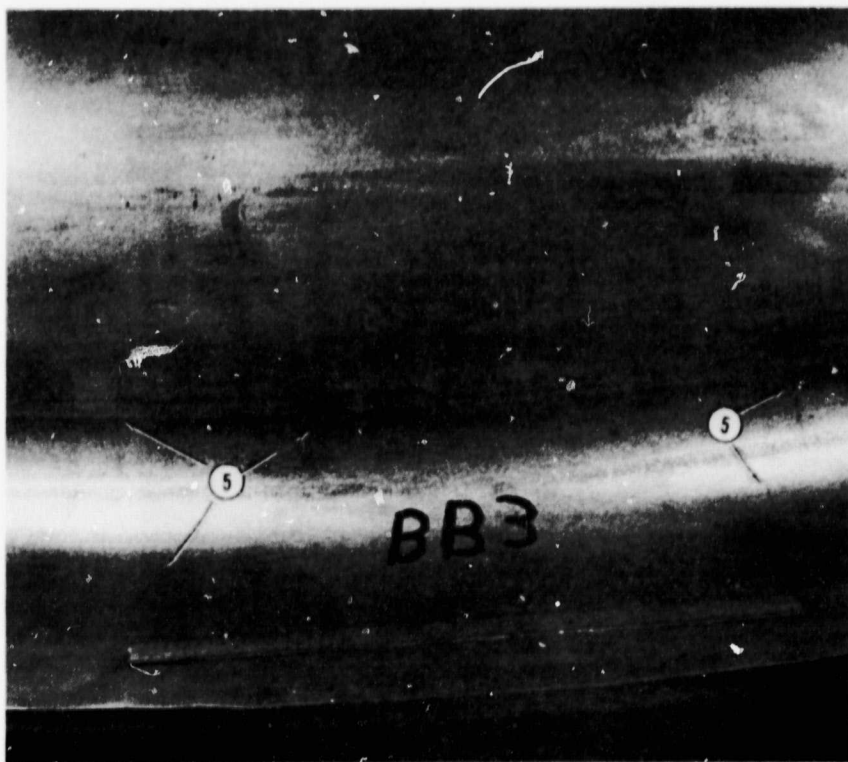
Figure 2 Cracks in the Flange and above the Flange of Dome BB3

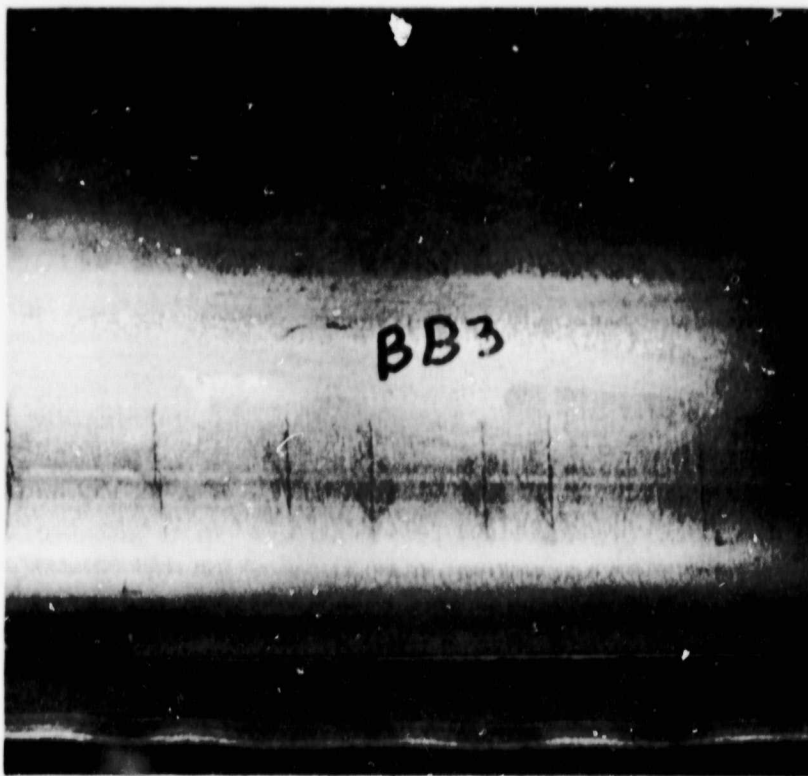
Figure 3 Cracks above the Flange of Dome BB3

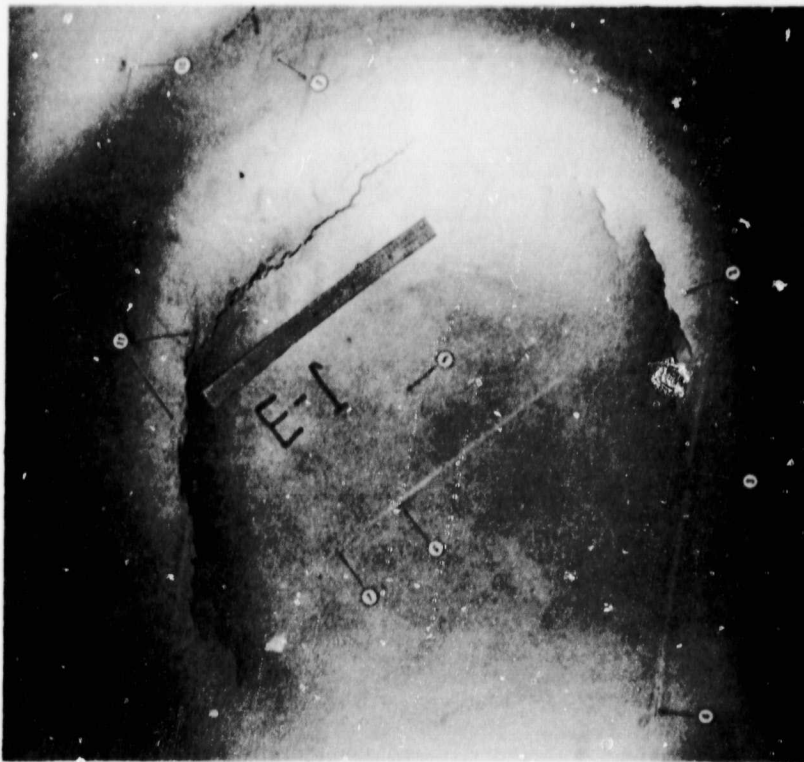
Figure 4 Cracks on the Inside Surface Near the Apex of Dome E1
